# Energy loss in a food factory

**Company**      A Food Manufacturer      Tester:  
Testo

**Task**      Thermal Survey

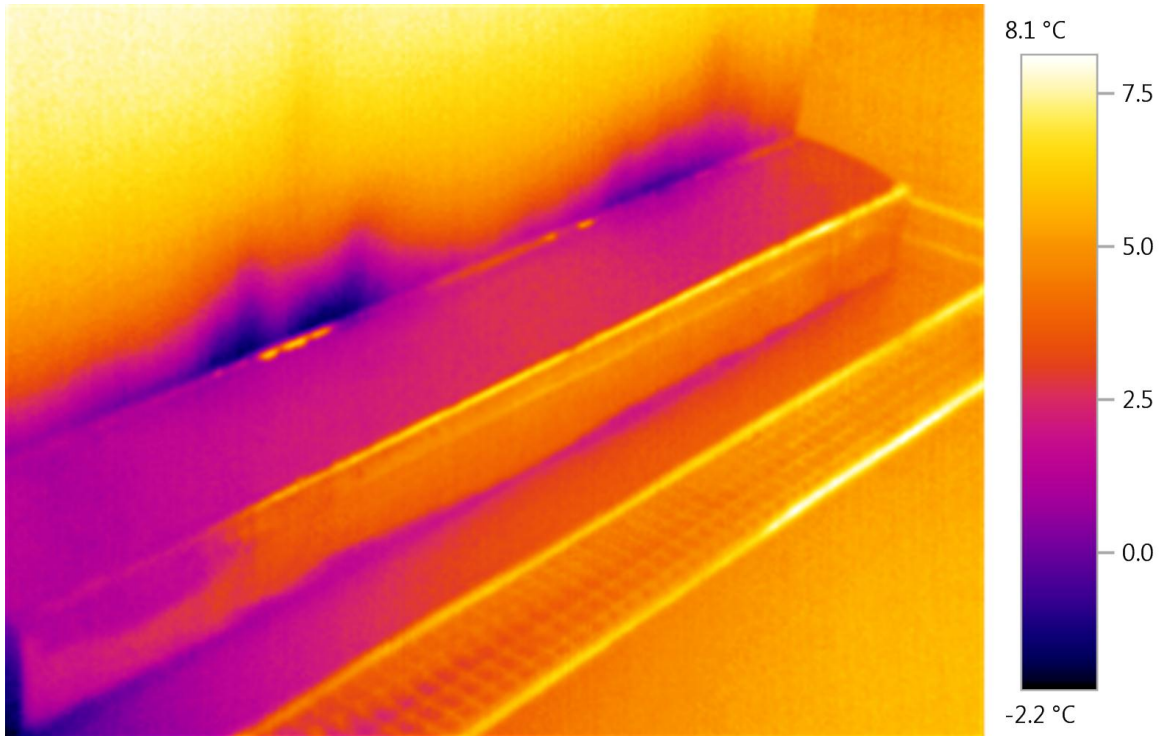
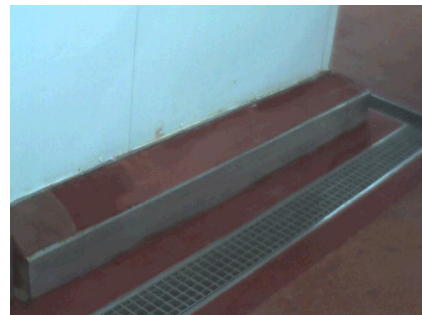
**File:** External Chiller Wall with Faulty Seal.BMT

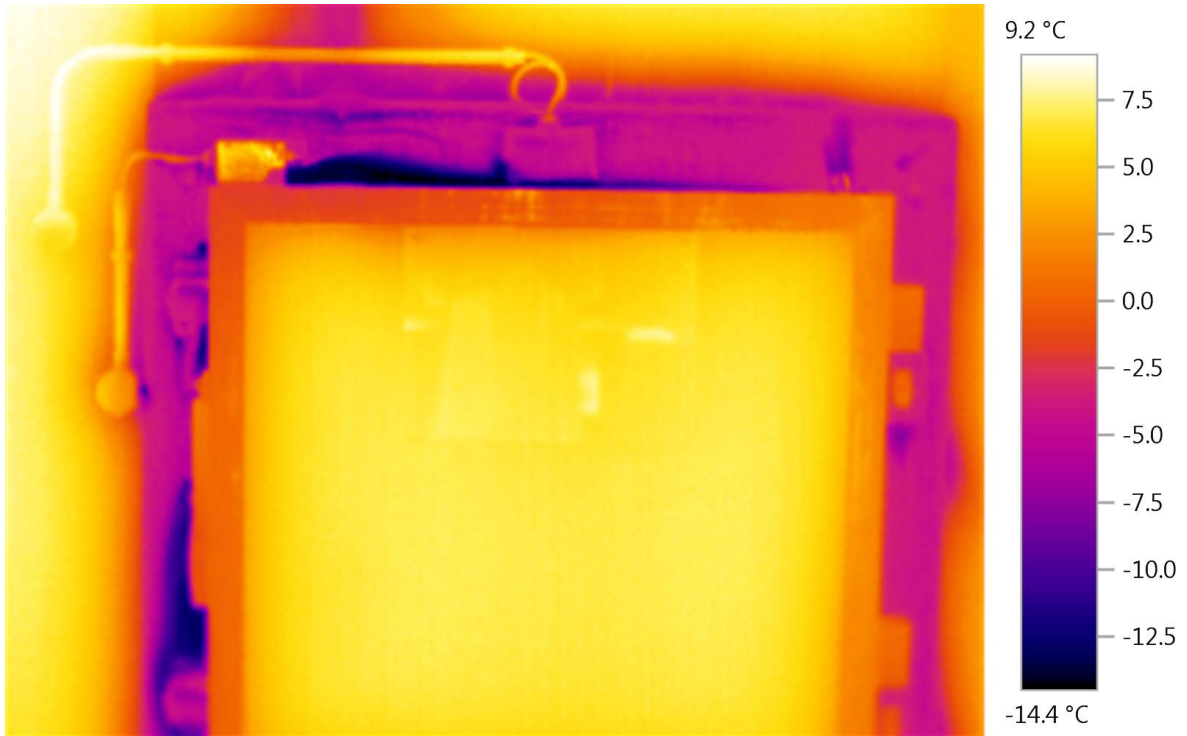
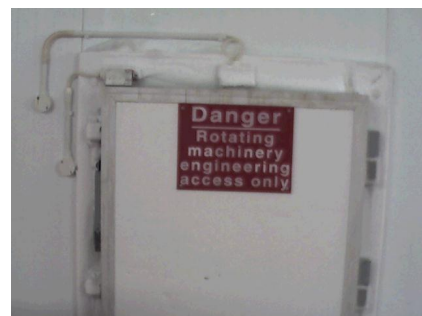
**File:** Chiller Door - Innefective Seal - Top Left.BMT

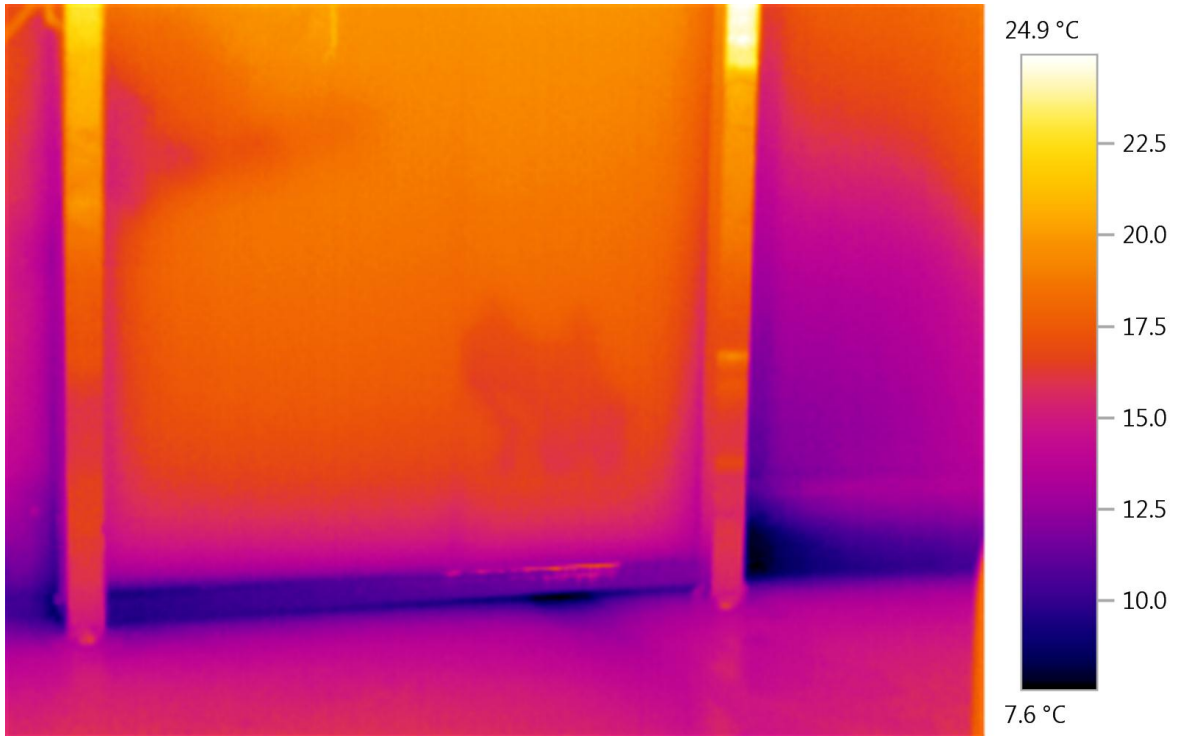
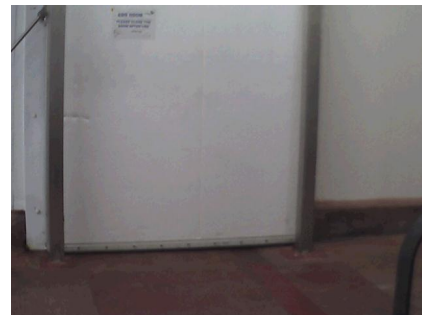
**File:** Feezer Door - Cold Air Escaping Bottom Left.BMT
