APPENDIX 7 Examples of details submitted as photographic evidences (England and Wales)

ADL §B7 (1) Foundations/substructure and ground floor, to show thermal continuity and quality of insulation in the following places.

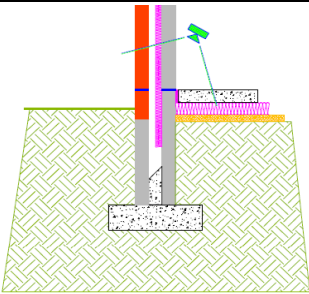
<p>ADL1, B7, 1a. at ground floor perimeter edge insulation. Insulation under floor slab</p>

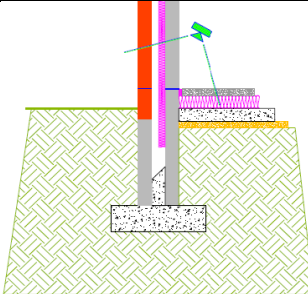
<p>ADL1, B7, 1a. at ground floor perimeter edge insulation. Insulation above floor slab</p>

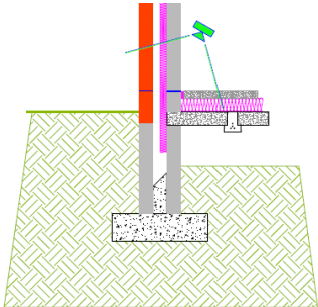
<p>ADL1, B7, 1a. at ground floor perimeter edge insulation. Insulation above suspended floor slab or B&B</p>
1b	At external door threshold.	1 photo

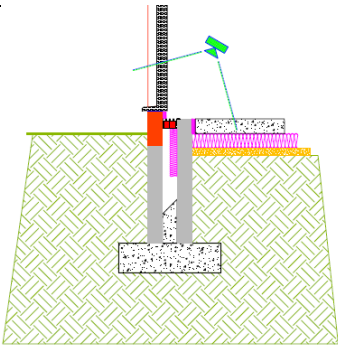
<p>ADL1, B7, 1b. at external door threshold. Insulation under floor slab</p>

Note: Regarding "at external door threshold"; it could be a combination of E3 (sill) and E5 (ground floor) so what needs to be photographed, as if the door sits on top of the DPC (Damp Proof Course) then there is no E3.

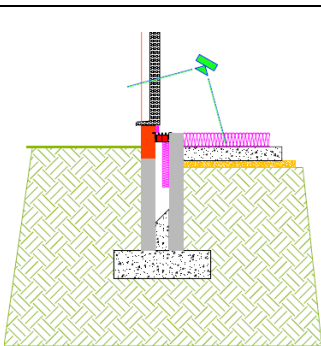
<p>ADL1, B7, 1b. at external door threshold. Insulation above floor slab</p>

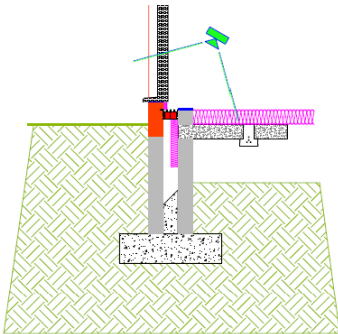
<p>ADL1, B7, 1b. at external door threshold. Insulation above suspended floor slab or B&B</p>

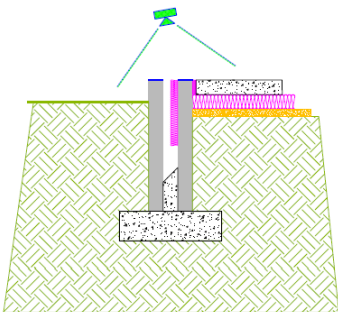
<p>ADL1, B7, 1c. below damp proof course on external walls. Insulation under floor slab</p>

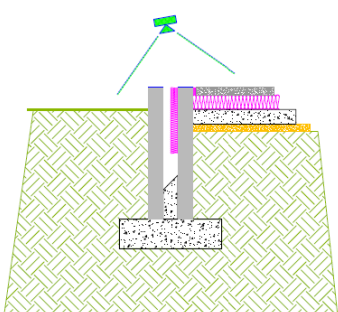
<p>ADL1, B7, 1c. below damp proof course on external walls. Insulation above floor slab</p>

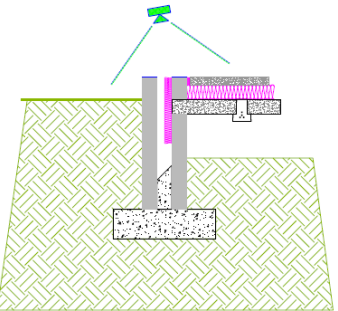
<p>ADL1, B7, 1c. below damp proof course on external walls. Insulation above suspended floor slab or B&B</p>
<p>* an additional close up photo can be added only when necessary</p> <p>Note: The quality of photos should be subject to ADL §B7.</p>

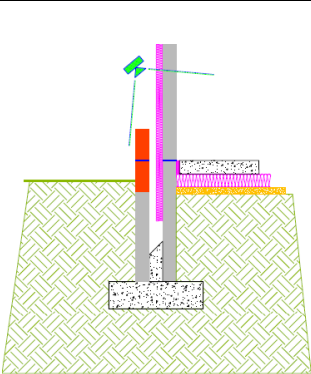
<p>ADL1, B7, 2a. Ground floor to wall junction. Insulation under floor slab</p></div> <div>

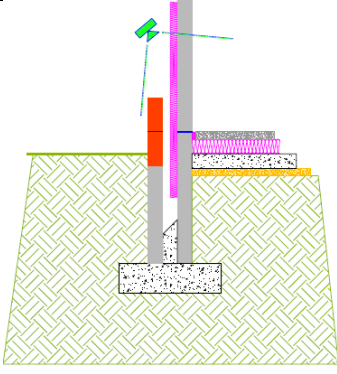
<p>ADL1, B7, 2a. Ground floor to wall junction. Insulation above floor slab</p></div> <div>

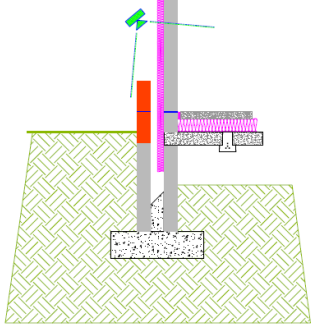
<p>ADL1, B7, 2a. Ground floor to wall junction. Insulation above suspended floor slab or B&B</p></div>

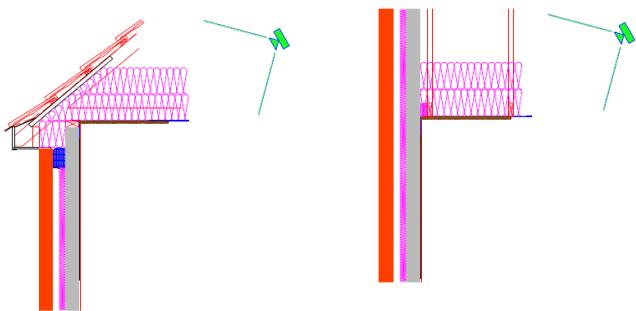
<p>ADL1, B7, 3b. Eaves and gable edges.</p> <p>ADL1, B7, 3b. Eaves and gable edges.</p>
<p>* an additional close up photo can be added only when necessary Note: The quality of photos should be subject to ADL §B7.</p>

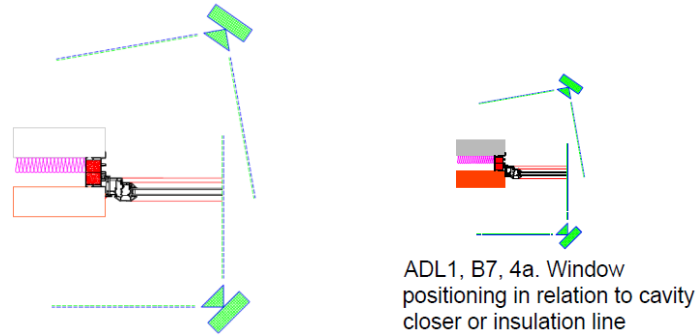
<p>ADL1, B7, 4a. Window positioning in relation to cavity closer or insulation line</p>
4b	External doorset positioning in relation to cavity closer or insulation line	1 photo
