Impact Study: Vibration Station

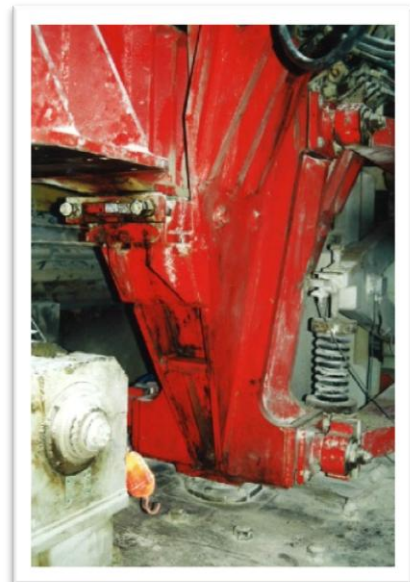
This was achieved by gripping the dry-filled mould at a vibration station, weighing over 2 tonnes, shown here in red, and repeatedly lifting and dropping it onto an anvil. The operation worked well but the vibration station itself suffered unacceptable cracking, emanating from a point which did not appear to be a significant stress raiser.

These analyses clearly showed the cause to be stress wave focussing; the stress wave caused by the impact with the anvil was travelling through the very heavy mould gripper, reflecting off various surfaces and combining at one unfortunate point so that it was seeing stresses comparable with those at the anvil impact point.

Instead of the impact stresses being gently eased as they spread up through the increasing cross sectional area of the gripper shown in the photograph, they were recombining at a seemingly minor geometric discontinuity.

The fix was a small change to the geometry, optimised by analysis, which we were able to show avoided this focussing effect and, most importantly, did not push the problem to some other unfortunate part of the structure.
