Testing high-voltage plants with thermal imagers from Testo.

Thermography increases reliability of supply

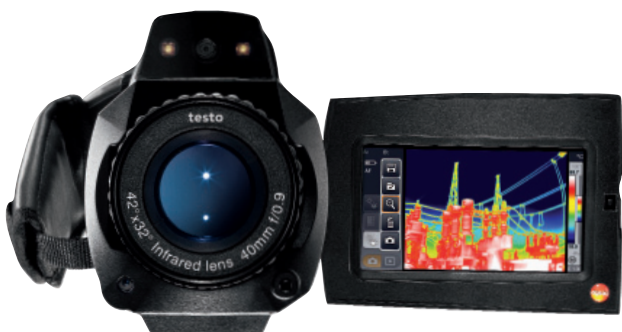
Thermal imager testo 890

With the high-resolution thermal imager testo 890, these sources of malfunction can be quickly and precisely identified before they become serious problems endangering the reliability of supply. The wide-angle lens of the imager quickly provides a meaningful overview of the overall status of the plant being tested. In order to assess distant measurement objects precisely, the telephoto lens is recommended. It reliably and precisely measures objects with a size of 19 mm from a distance of 15 m. Anomalies, so-called hotspots, are identifiable from a size of approx. 6 mm. This allows the smallest cable ruptures or warming in circuit breakers, for example, to be evaluated from a safe distance. The large fold-out, rotatable display of the testo 890 allows overhead imaging work, and in combination with the rotating, ergonomic grip, the imager can be confidently handled even in difficult-to-access places. Finally, the status of the system being tested can be professionally documented using the intuitive evaluation functions and the easy report creation of the analysis software IRSofT.
