TESTO INDUSTRY REPORT

How Thermal Imaging Can Help Domestic Heating Engineers Reduce Costs and Sell More

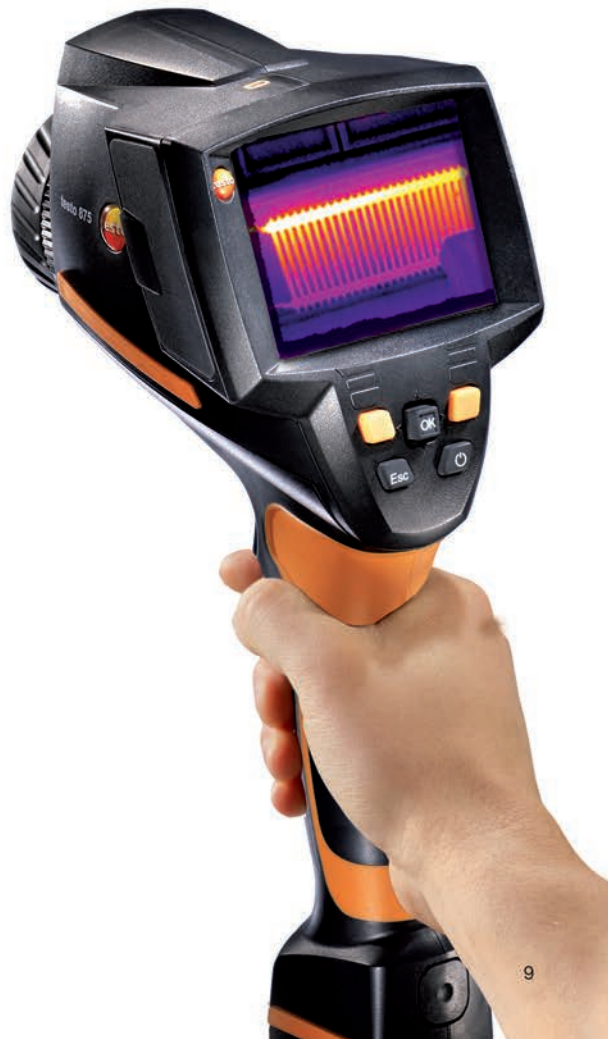
It is clear from the results that using a thermal imaging camera gives Heating Engineers the edge and the customer added value. A thermal imaging camera will show the condition of radiators before, during and after the power flushing process and verify the improvements that the process produces. This level of analysis and extra reassurance to the customer demonstrates a high level of professionalism.

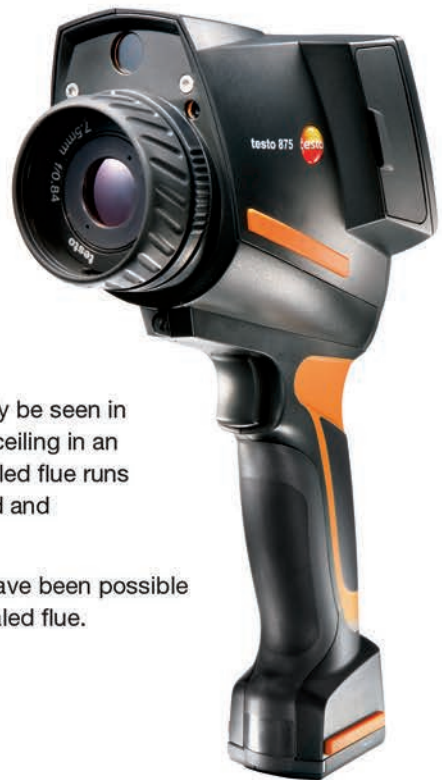
Here the location of the concealed flue can clearly be seen in the thermal image running in the void above the ceiling in an apartment. Having established where the concealed flue runs the positions of inspection hatches can be marked and subsequently cut and installed.

Without a thermal imaging camera it would not have been possible to visually locate the exact position of the concealed flue.

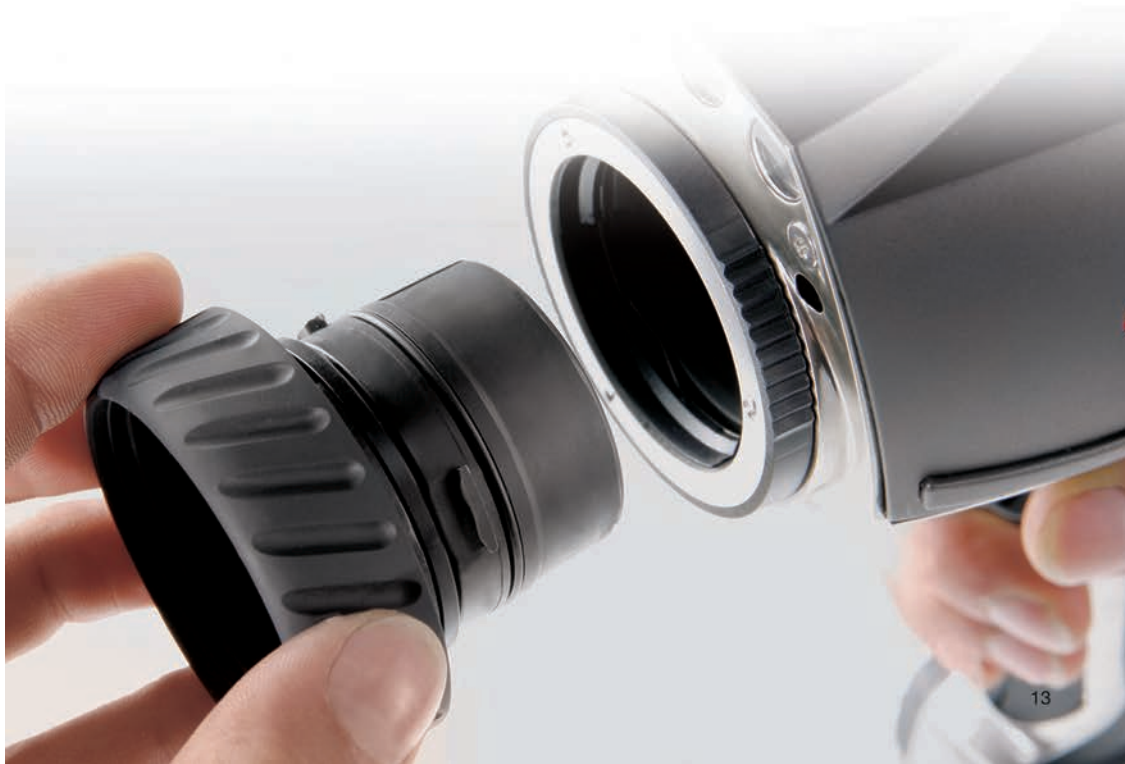
Focus

The prerequisite for any thermography measurement is a properly focused subject. A blurred image cannot be corrected and is not presentable. The focus arrangement has to provide easy focusing as the subject must be focused correctly.

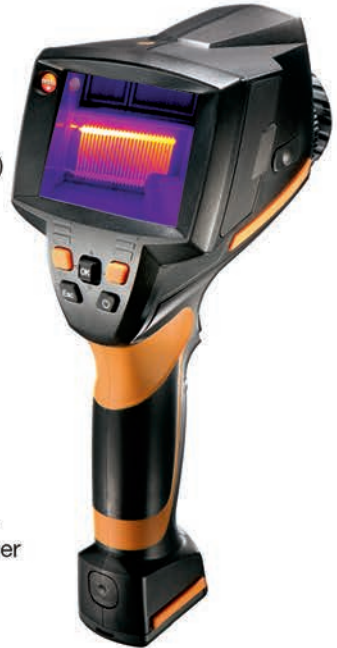
The Testo 875 Series Thermal Imaging Cameras are an ideal investigative tool for HVAC applications:

- Large 3.5" display with high resolution image
- Exchangeable wide angle (32°) & telephoto lens (optional)
- Thermal sensitivity <math>< 0.08^{\circ}\text{C}</math>, (80mK)
- Integrated digital camera, (Testo 875-2)
- Minimum focus distance - 10cm
- Manual control of scale, to set span and level
- Auto Hot / Cold Spot Recognition
- Save up to 1,500 images to the SD memory card
- Powerful software with full reporting features
- Two year warranty

Easy to use and capable of producing professional results, the Testo 875 is the perfect solution for the Heating Engineer who is looking to utilise thermal imaging. The Testo 875 Thermal Imaging Camera costs from as little as £1,895.
