CASE STUDY FOR SIX INDIVIDUAL 5-A-SIDE PITCHES, DEESIDE LEISURE CENTRE

Project Name: Deeside Leisure Centre

Project Address: Deeside Leisure Centre, Flintshire, CH5 1SA

Size of Project: 4224m² - 6no pitches @ 704m² per pitch

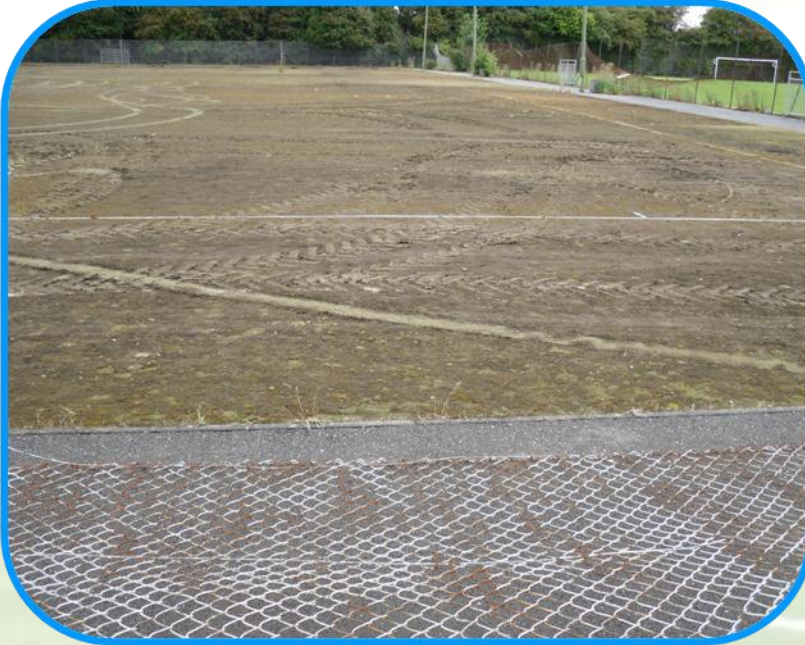
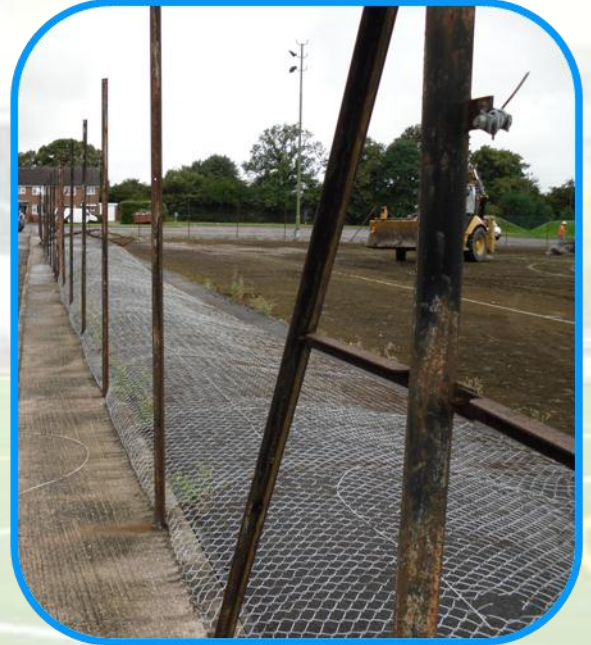
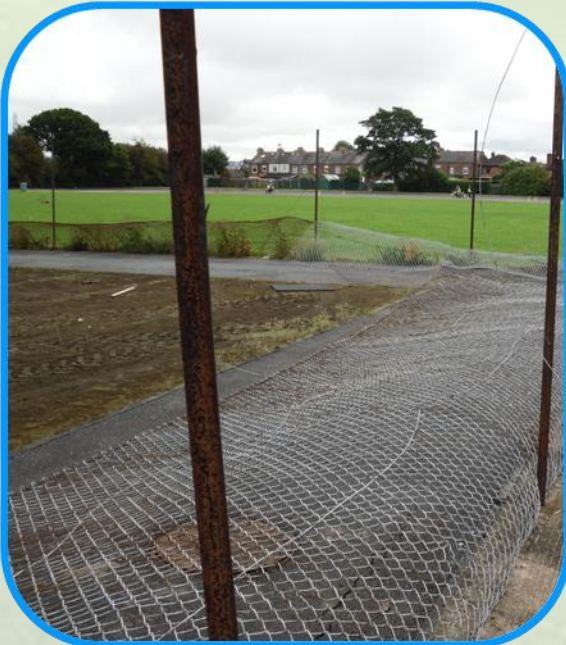
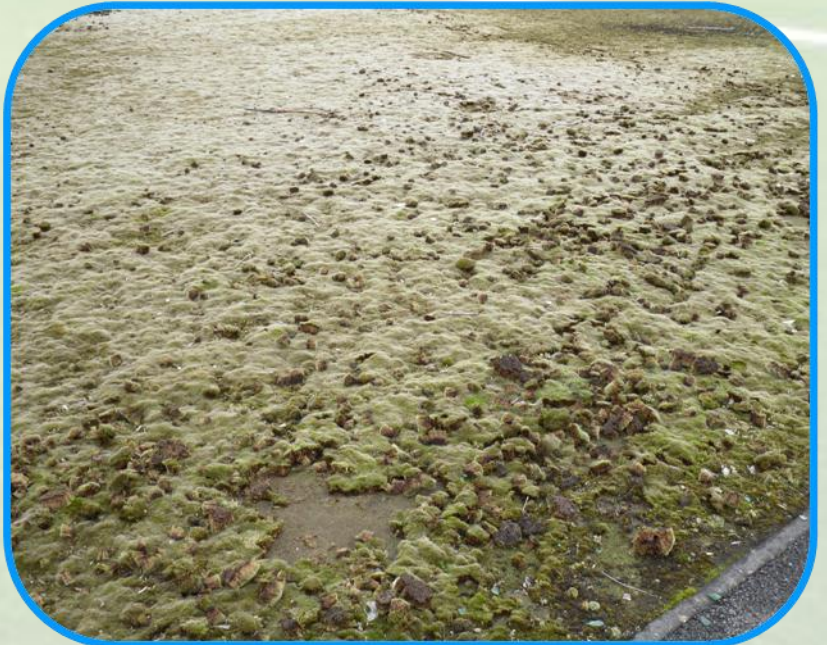
BEFORE

The existing surface was in a derelict state and was unusable as it wasn't safe for the public. The 6400m² pitch needed to be fully ripped out along with the old floodlights and fencing as all was in a poor condition. It was basically a full demolition project of an old astroturf sports surface.

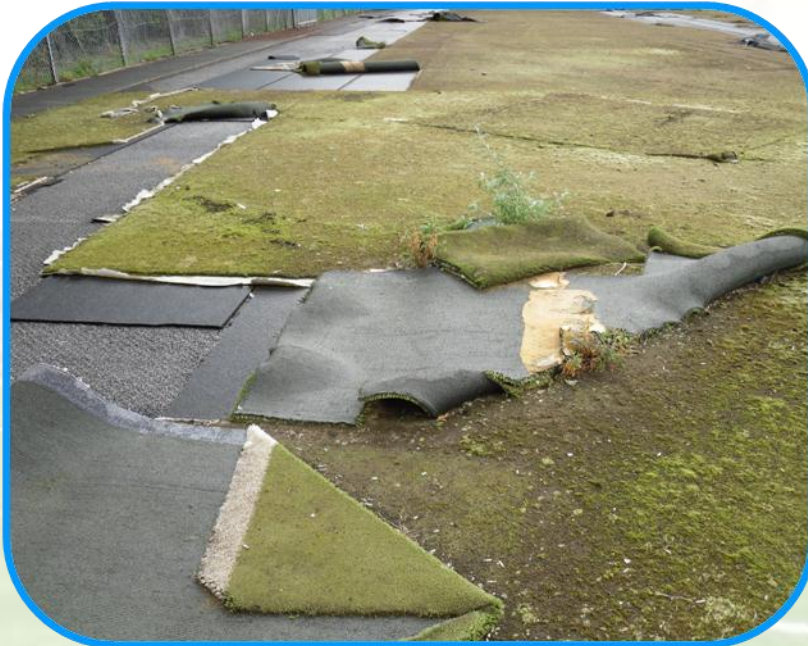
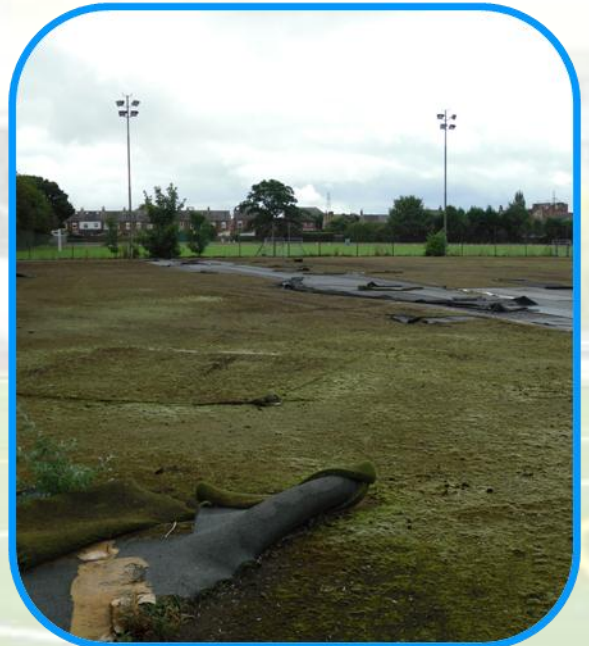
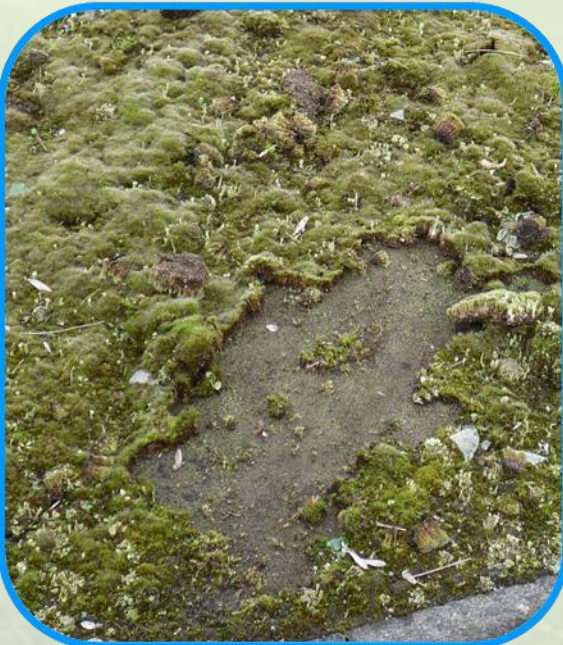
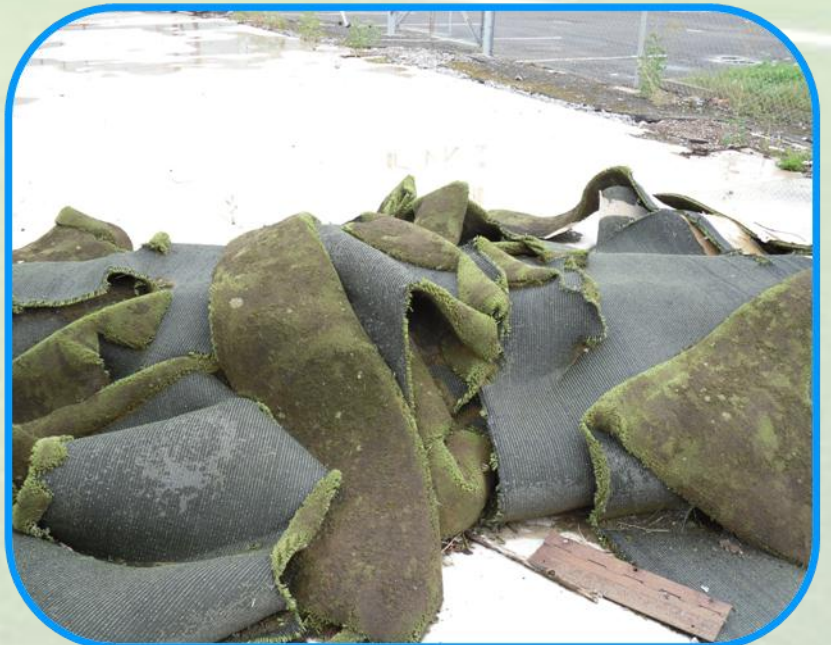
REMOVAL OF EXISTING SYNTHETIC TURF

The existing artificial grass surfacing as shown in the pictures below was full of moss, had failed at the seams and needed to be fully replaced. The shockpad also had to be removed; however the macadam base that they had been installed on was still in fine condition to use for the new sub base.
