# Marine Industry

## Case Study: HDPE with the waterjet

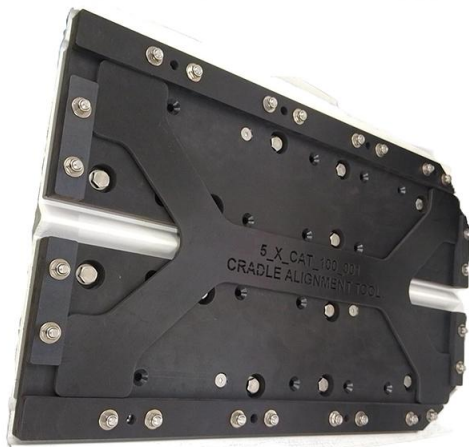
**Solutions:** Using our world class precision pneumatic drill and top of the range Waterjet machines enabled us to mitigate any issues with cracking and remove the requirement to “pierce” the material. The waterjet process ensured that each piece was cut to precise dimensions. The requirement was also to provide precision countersinking and tapped holes to ensure the parts were ready for assembly once they arrived on site.
